ROAD SAFETY AUDIT

Bartlett Street

Town of Northborough

10/28/2021

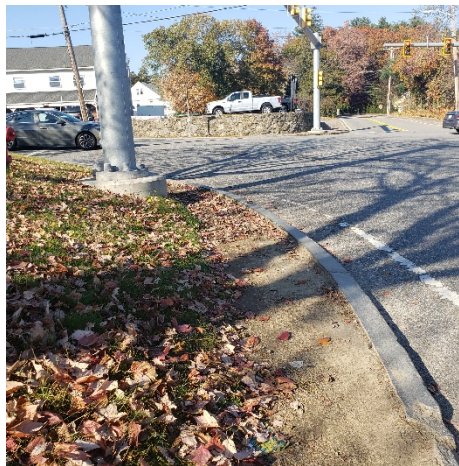
Figure 5: Tire Ruts on Bartlett Street

Observations: It was observed that large vehicles such as tractor trailers or school buses had difficulty turning onto Bartlett Street from both sides of Main Street. This was made evident at the RSA as tire marks were observed over the curb in the grass from vehicles turning right on to Bartlett Street from Main Street (eastbound) (have photos). The RSA team also commented on lack of adequate pedestrian infrastructure given the high usage of high school students using the intersection to access their homes and retail establishments on both sides of Main Street. Among the four approaches to the intersection there is only one signalized crosswalk that is on the east side of the intersection. Residents voiced concerns that right-on-red turning movements are allowed and that many drivers do not pay attention to pedestrians in the crosswalk when attempting to make a right-turn maneuver from Bartlett Street onto EB Main Street. Additionally, there are only sidewalks on one side of Bartlett Street and no sidewalks on Main Street despite access to retail businesses and Saint Bernadette’s School at the intersection.

- Work with MassDOT to develop long term design recommendations for the intersection. The design should include accommodations for trucks turning in and out of Bartlett Street and pedestrian improvements at the intersection and access to retail businesses on Main Street.
- Work with MassDOT as a short-term measure to consider moving back the stop bar on Bartlett Street to allow for additional turning radii for trucks turning into Bartlett Street.
- Work with MassDOT to evaluate current signal timing with special attention for left turns onto Main Street.
- Work with MassDOT to evaluate short and/or mid-term improvement for right turns from Main Street EB into Bartlett Street SB and Bartlett Street NB to Main Street EB.

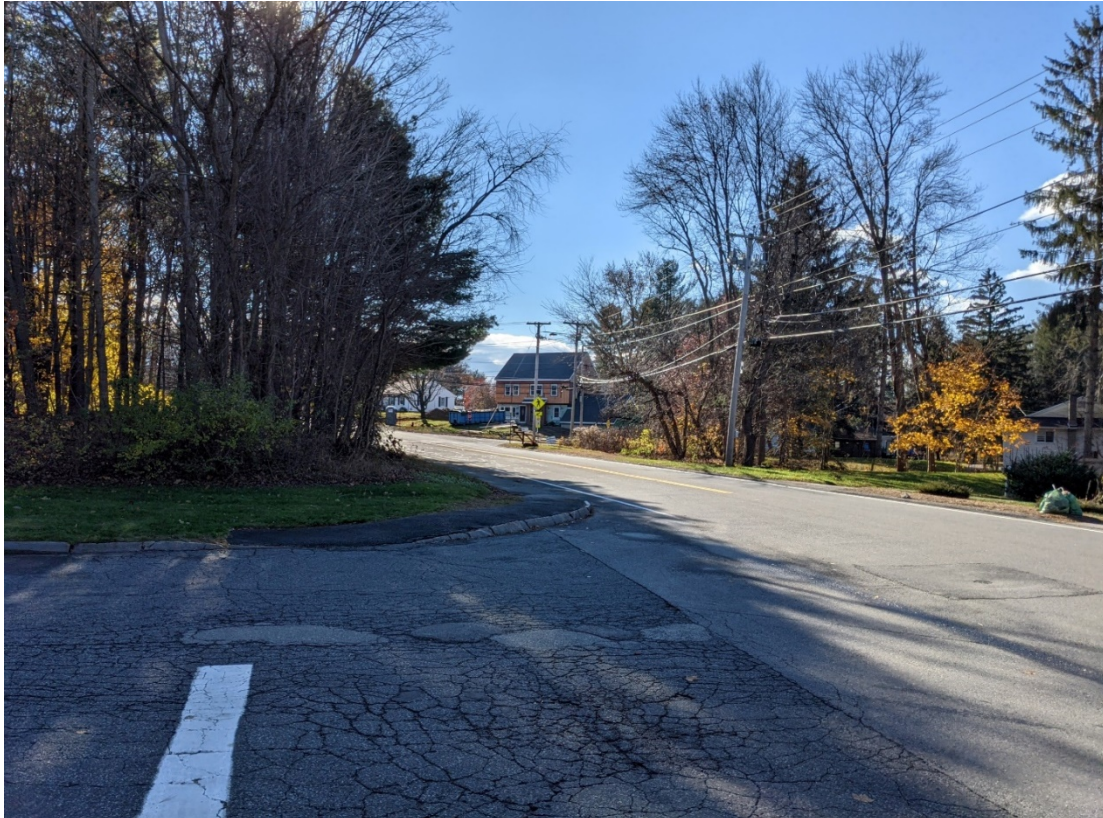
Figure 9: Hemlock Drive Limited Sight Lines

Bartlett Street and Hemlock Drive – A T-intersection with both roads having one travel lane in each direction. There is a stop sign at the end of Hemlock Drive. Vegetation impedes the line of sight of motorists exiting Hemlock Drive on to Bartlett Street. The position of the stop line is set far back, and drivers must move past the stop line to observe traffic movements.

Observations: Vegetation currently obstructs the line of sight for motorists exiting Hemlock Street on to Bartlett Street. It was observed that the current stop line is placed far back from the road and makes it difficult to observe motorists traveling on Bartlett Street towards Route 20. Hemlock Street's pavement shows signs of wear through alligator cracking at the intersection.

- Clear back brush that impedes sight lines
- Repaint stop line closer to Bartlett Street
- Repave or seal parts of Hemlock Street

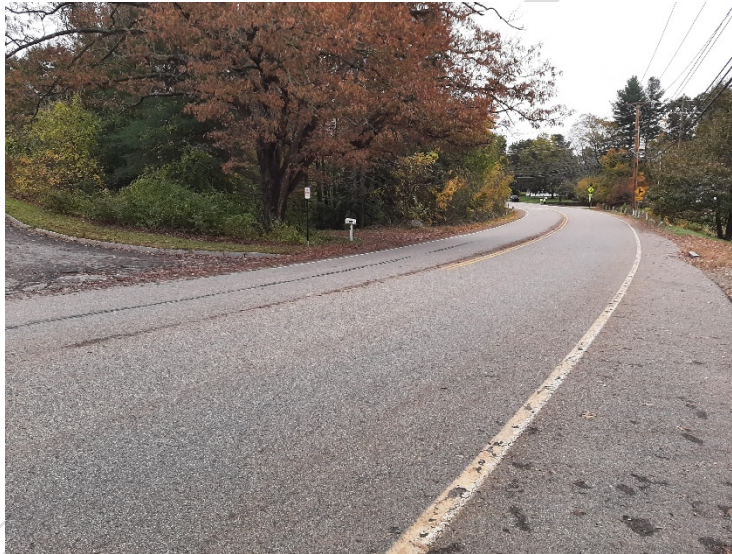
Figure 14: Poor Sightline from Jenkins Drive as Bartlett Curves

Bartlett Street and Jenkins Drive – A T-intersection with no marked lanes on Jenkins Drive. Bartlett Street has one travel lane in each direction. Bartlett Street curves at this intersection. There is a poor line-of-sight for vehicles turning onto Jenkins Drive from Bartlett Street heading east. Additionally, vehicles departing Jenkins Drive on Bartlett Street have a poor line-of-sight in both directions.

Observations: The entrance and exit for Jenkins Drive is on a curve of Bartlett Street traveling west. The combination of the curve in the road and the vegetation limit sightlines for vehicles entering and exiting Jenkins Drive. Some residents use Stirrup Brook Lane to get onto Bartlett Street for better sightlines and improved safety. Right next to Jenkins drive there is a hidden driveway for an independent property that is not visible from Bartlett Street.

- Consider adding blind driveway signs on westbound lane after crosswalk warning vehicles of upcoming driveways and streets.
- Clear brush from side of road to increase visibility for all vehicles.

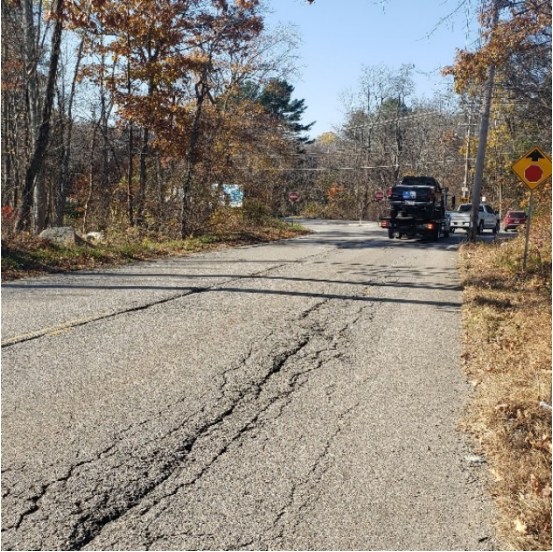
Figure 23: Pavement on Cedar Hill Road in Marlborough

Observations: The intersection was recently designed with new channelized islands and geometry. Stakeholders and residents at the RSA were generally happy with the redesign. Participants at the RSA made note of the poor pavement condition of Cedar Hill Street in Marlborough. A representative of ARHS also stated that the pavement conditions on Cedar Hill Street in Marlborough was one of their biggest concerns for student (teen driver) safety. A lack of lighting was noted at the intersection. Pedestrian infrastructure exists west of the intersection on Bartlett and the Aqueduct trail.

- Improve lighting at intersection.
- Consider communicating with Marlborough to work out a repaving plan for Cedar Hill Street.

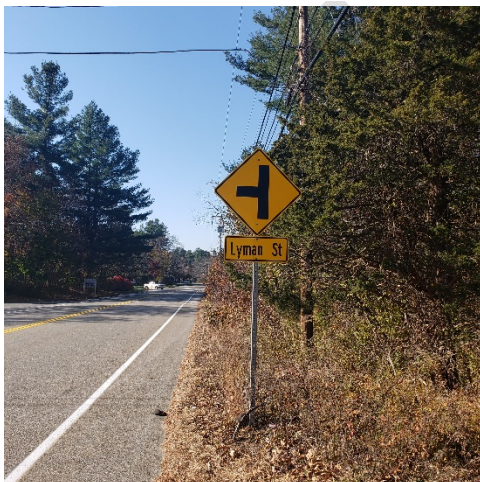
Figure 46: Signage for T-Intersection for Lyman

Observations: The intersection of Bartlett Street and Lyman Street had some major concerns during the RSA. Despite a 'stop sign ahead' on Lyman St approaching Bartlett St., residents and observers at the RSA noted that the actual stop signs on Lyman Street at Bartlett Street seem to sneak up on drivers. There have been multiple accidents at this location. During the RSA, there was no longer a guardrail on Bartlett Street as two vehicles had recently crashed through it. There is a larger boulder at the end of the property on the Southeast corner of the T-intersection to prevent vehicles from driving over the grass and the property line. Another observation was that vehicles traveling on Bartlett Street predominantly WB occasionally stop although there is no stop sign on Bartlett Street (courtesy stops) for vehicles making a left turn onto Bartlett Street while exiting Lyman Street. This action often causes confusion for drivers behind the stopped vehicle on Bartlett Street causing hazardous driving behavior. There is signage directing traffic to Route 495 at the end of Lyman Street and the intersection has a streetlight.

- As a short-term measure consider adding reflectors on stop-sign pole and improve visibility/presence of the advance warning signs on Lyman Street.
- Long – term improvement should consider intersection geometry redesign and box widening at Lyman Street.
- Mid-term improvement should consider adding a flashing stop sign for Lyman Street.
- Consider adding flashing warning signs for Bartlett Street.
- Long term improvement should consider advisory shoulders to narrow the road.

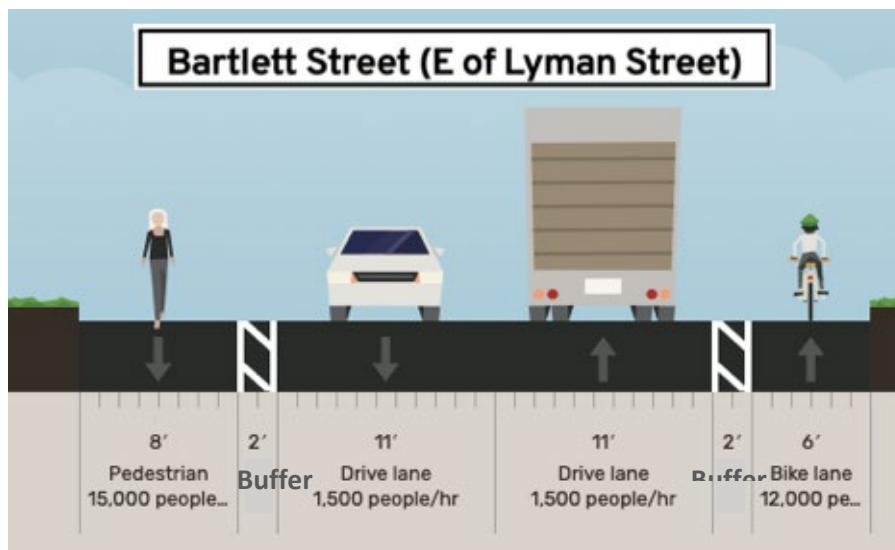
Figure 47: Pedestrian Improvements to Bartlett Street

Between Cedar Hill Street and Lyman Street the measured roadway width can accommodate bicycle and pedestrian facilities. It is important to note that while implementing these types of accommodations in an otherwise unconnected network could lead to potential conflicts at other locations. Currently, there are no separated bicycle or pedestrian facilities on Cedar Hill Street or Lyman Street.

It is recommended to incorporate temporary accommodations to include a 6-foot bike lane EB toward Marlborough and an 8-foot on-road path WB for use by bicyclists and pedestrians. There is also enough space to include a 2-foot painted barrier separating these facilities. These accommodations will create linkages to the intersecting portions of the Aqueduct Trail system and the existing bicycle lanes at the

It is recommended that the Town in conjunction with other entities such as Complete Streets/Master Planning Implementation committees monitor the use of these accommodations to determine the need for permanent infrastructure in the future.
