ROAD SAFETY AUDIT

Bartlett Street

Town of Northborough

10/28/2021

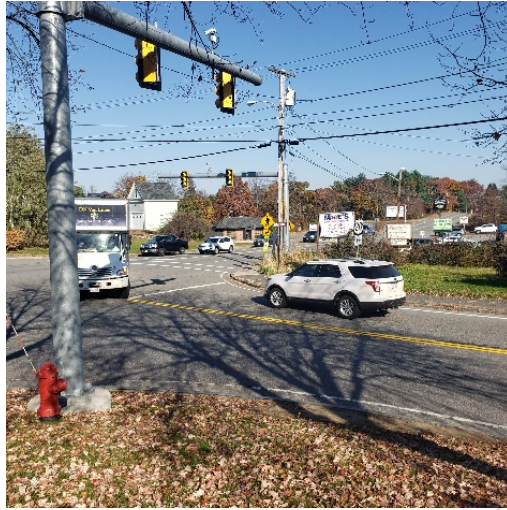
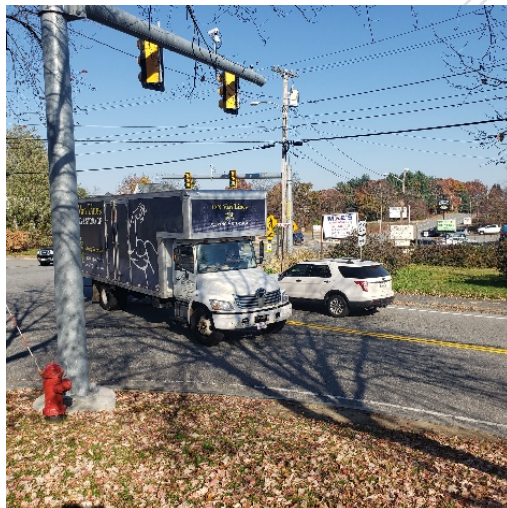
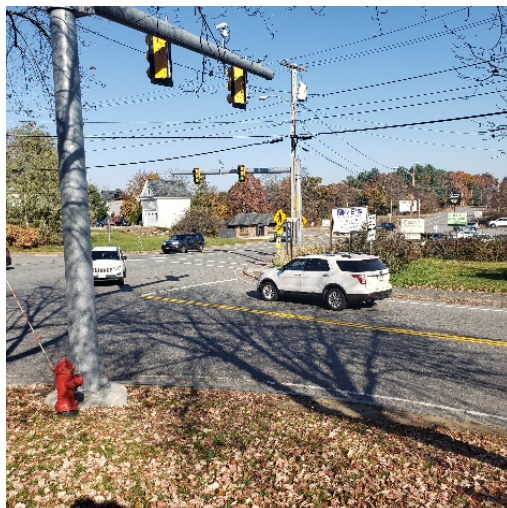
Figure 7: Vehicle Stopped Behind Line to Allow Truck Movement

Observations: It was observed that large vehicles such as tractor trailers or school buses had difficulty turning onto Bartlett Street from both sides of Main Street. This was made evident at the RSA as tire marks were observed over the curb in the grass from vehicles turning right on to Bartlett Street from Main Street (eastbound) (have photos). The RSA team also commented on lack of adequate pedestrian infrastructure given the high usage of high school students using the intersection to access their homes and retail establishments on both sides of Main Street. Among the four approaches to the intersection there is only one signalized crosswalk that is on the east side of the intersection. Residents voiced concerns that right-on-red turning movements are allowed and that many drivers do not pay attention to pedestrians in the crosswalk when attempting to make a right-turn maneuver from Bartlett Street onto EB Main Street. Additionally, there are only sidewalks on one side of Bartlett Street and no sidewalks on Main Street despite access to retail businesses and Saint Bernadette’s School at the intersection.

- Work with MassDOT to develop long term design recommendations for the intersection. The design should include accommodations for trucks turning in and out of Bartlett Street and pedestrian improvements at the intersection and access to retail businesses on Main Street.
- Work with MassDOT as a short-term measure to consider moving back the stop bar on Bartlett Street to allow for additional turning radii for trucks turning into Bartlett Street.
- Work with MassDOT to evaluate current signal timing with special attention for left turns onto Main Street.
- Work with MassDOT to evaluate short and/or mid-term improvement for right turns from Main Street EB into Bartlett Street SB and Bartlett Street NB to Main Street EB.

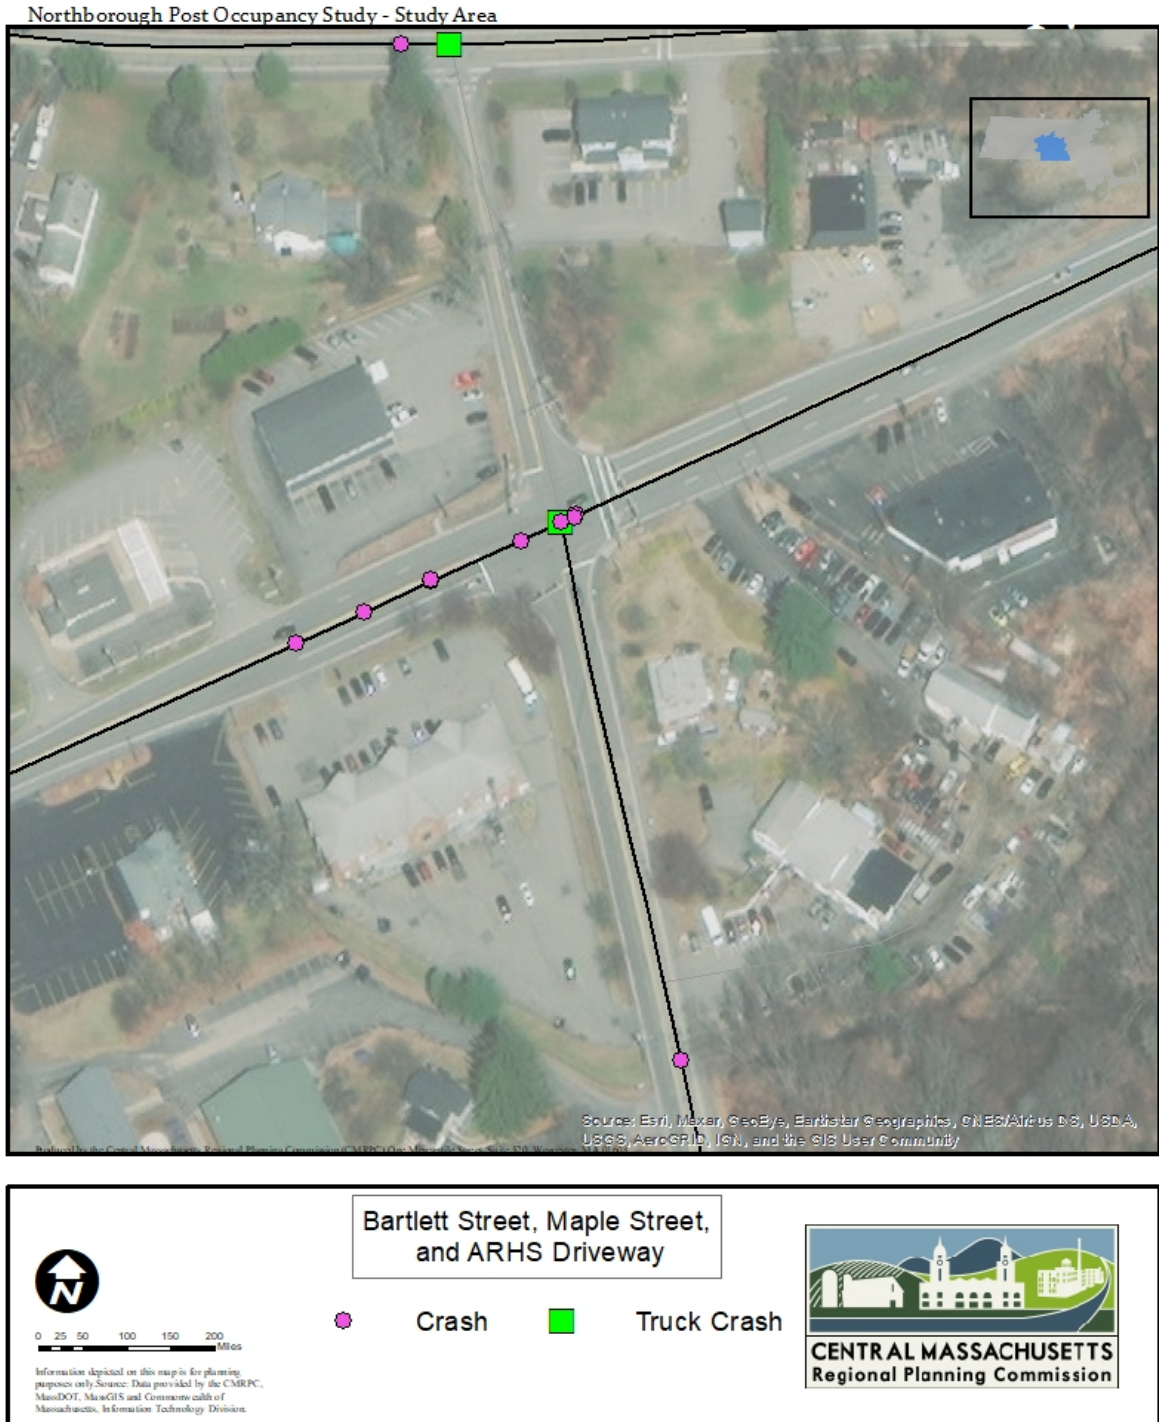
Figure 8: Crashes at Bartlett/Main

- HSIP Cluster:** The Bartlett Street and Main Street (MA-20) intersection is considered a Highway Safety Improvement Program (HSIP) eligible cluster. That is a crash cluster which has the total number of “equivalent property damage only” crashes in the area are within the top 5% of all clusters in that region. Being HSIP-eligible makes the location eligible for Federal Highway Administration (FHWA) and MassDOT funds to address the identified safety issues at these locations.

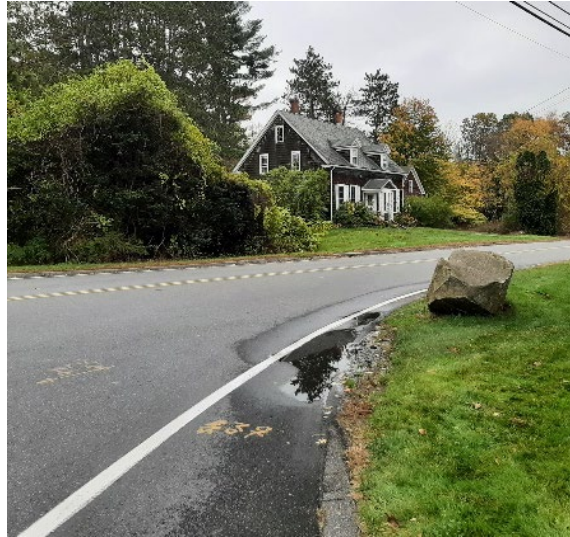
Figure 15: Rock Placed by Town to Prevent Vehicles on Grass

Observations: The intersection of Bartlett Street and Lyman Street had some major concerns during the RSA. Despite a 'stop sign ahead' on Lyman St approaching Bartlett St., residents and observers at the RSA noted that the actual stop signs on Lyman Street at Bartlett Street seem to sneak up on drivers. There have been multiple accidents at this location. During the RSA, there was no longer a guardrail on Bartlett Street as two vehicles had recently crashed through it. There is a larger boulder at the end of the property on the Southeast corner of the T-intersection to prevent vehicles from driving over the grass and the property line. Another observation was that vehicles traveling on Bartlett Street predominantly WB occasionally stop although there is no stop sign on Bartlett Street (courtesy stops) for vehicles making a left turn onto Bartlett Street while exiting Lyman Street. This action often causes confusion for drivers behind the stopped vehicle on Bartlett Street causing hazardous driving behavior. There is signage directing traffic to Route 495 at the end of Lyman Street and the intersection has a streetlight.

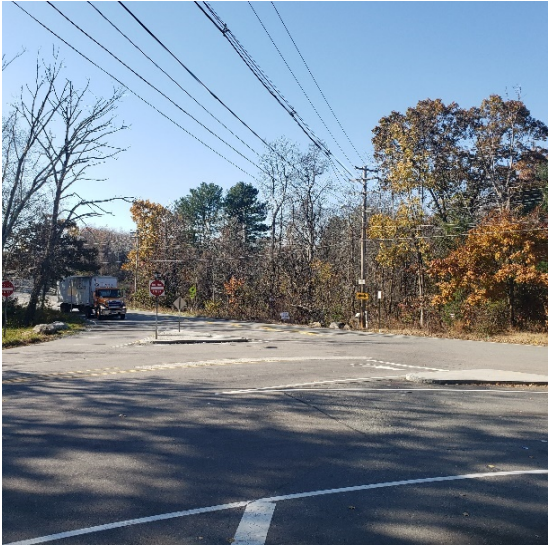
Figure 22: Cedar Hill Road Geometry after Redesign

Observations: The intersection was recently designed with new channelized islands and geometry. Stakeholders and residents at the RSA were generally happy with the redesign. Participants at the RSA made note of the poor pavement condition of Cedar Hill Street in Marlborough. A representative of ARHS also stated that the pavement conditions on Cedar Hill Street in Marlborough was one of their biggest concerns for student (teen driver) safety. A lack of lighting was noted at the intersection. Pedestrian infrastructure exists west of the intersection on Bartlett and the Aqueduct trail.

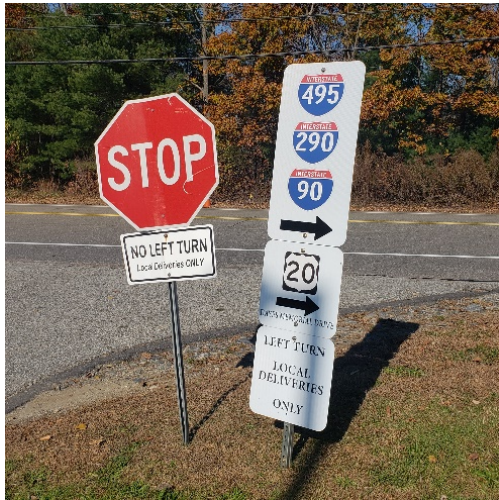
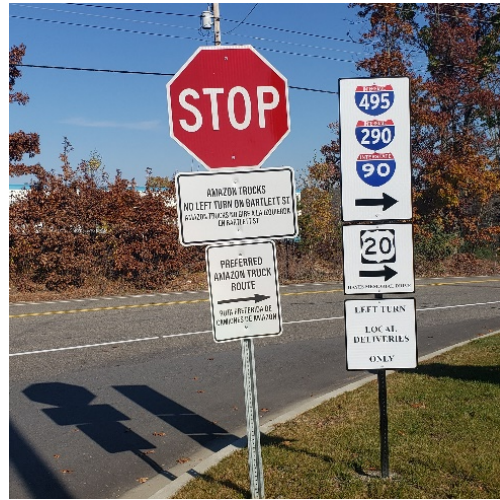
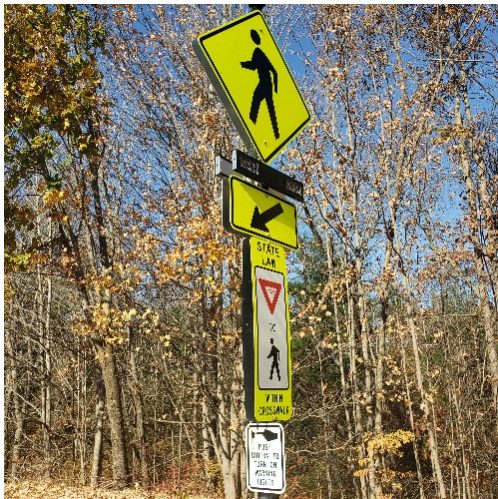
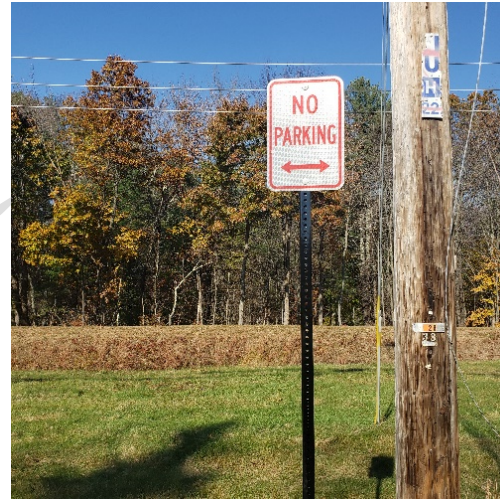
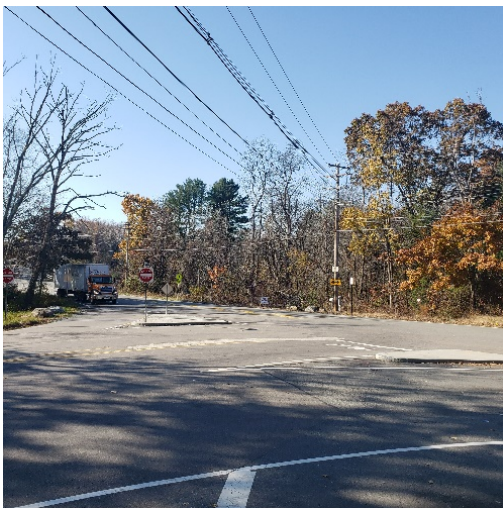
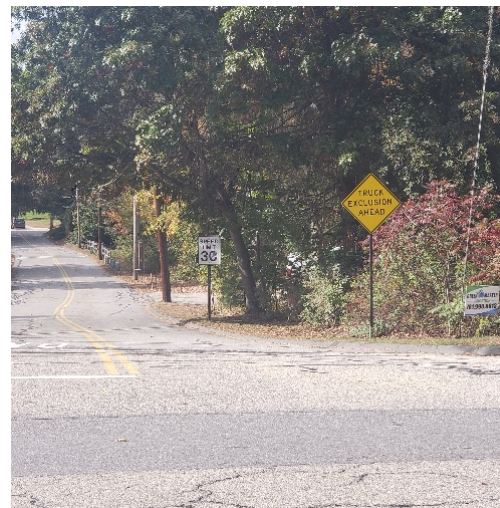
Figure 40: Corridor Improvements and Signage

- No Parking Zone throughout the Bartlett Street Corridor
- Installation of Rectangular Rapid Flashing Beacons at two crosswalks
- Truck exclusion on Maple Street
- Directional Signage at Amazon and A Duie Pyle, Inc. driveways
